Manhole Inspection Summary

Manhole # S43C__001MH

Insp Date: **4/13/08 12:26 PM**

Location Address: **Fairmount Ave**

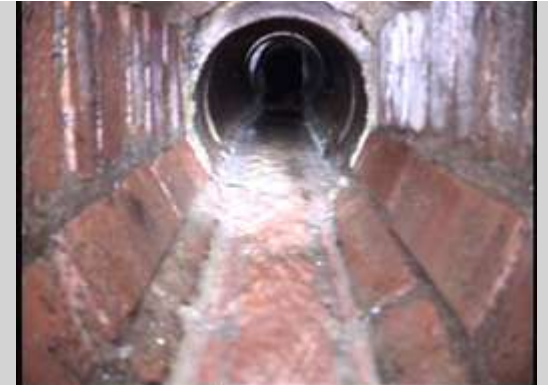
12 O'Clock Outflow

8 in. Circular Gravity Sewer
Pipe Out @ 12 O'Clock

Pipe Height: **8.4** (in.) Rod and Bar (Angled)
Pipe Material: **Clay** ☐ Pipe Lined
Invert Depth: **9.20** (ft.) Flow Characteristics: **Slow**
Deposits: ☒ None ☐ Mud ☐ Sludge ☐ Debris ☐ Grease
Silt Depth: (in.) Deposits Extent:
Infiltration: **None** Pipe Seal Cond: **Sound**

Drop: **None**

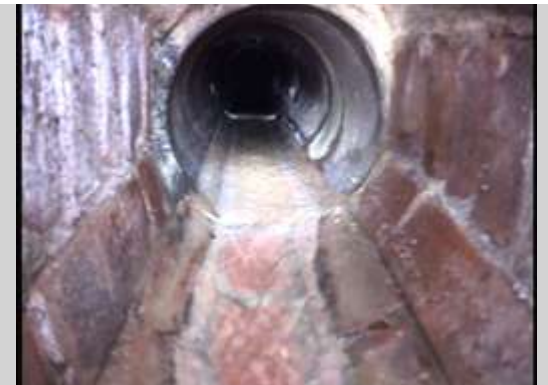
6 O'Clock Inflow

8 in. Circular Gravity Sewer
Pipe In @ 6 O'Clock

Pipe Height: **8.4** (in.) Rod and Bar (Angled)
Pipe Material: **Clay** ☐ Pipe Lined
Invert Depth: **9.10** (ft.) Flow Characteristics: **Slow**
Deposits: ☒ None ☐ Mud ☐ Sludge ☐ Debris ☐ Grease
Silt Depth: (in.) Deposits Extent:
Infiltration: **None** Pipe Seal Cond: **Sound**

Drop: **None**
